Nov. 15, 2003, VOLUME IV NUMBER XXII

Fire destroys family's home

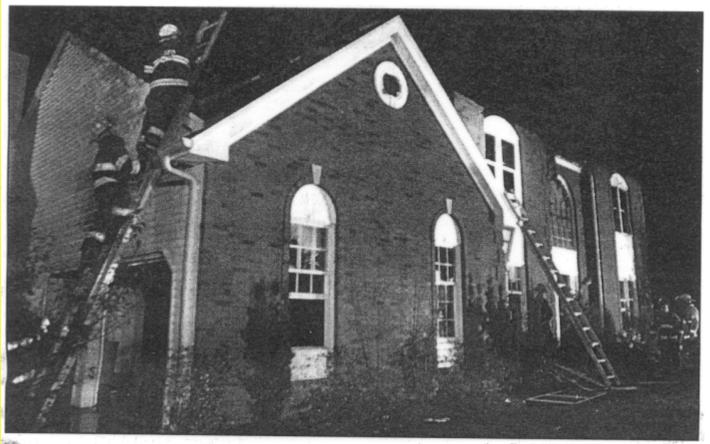
Firefighters work to put out the blaze that destroyed this home in Shrewsbury, Mass., while its owners were out visiting relatives on Diwali. The family had only been living in the home for a month after moving from Pittsburgh.

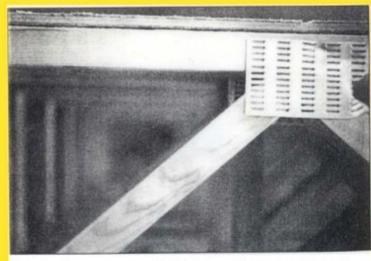
Flat 2 imes 4 trusses covered with plywood can easily be severed by power saws.

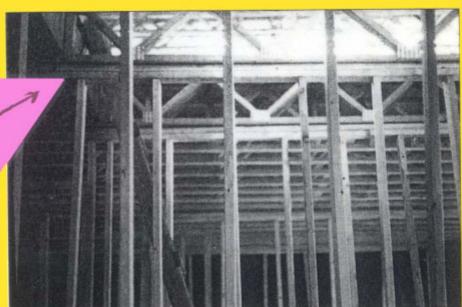
Flat 2 imes 4 trusses create a cockloft (more accurately, a trussloft) on each floor.
